## Sorrento Ro-Ro Passenger Ship Incident Considerations

Sorrento, fire on board, Ro/Pax,  
semi-open decks, thermal detectors,  
fire propagation, drencher system.

### ABSTRACT

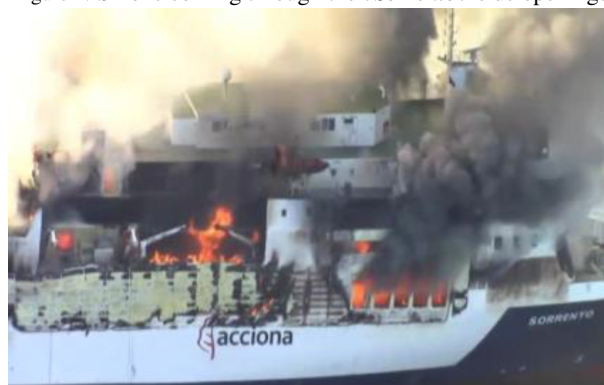
The reason to look at the side openings of the vehicle decks in the shell plating of the "Sorrento" class ships, is the fact that in the first images released of the incident can be seen the output of smoke whitish appearance by the same ones, which means that the incipient fire was burning freely, which is no less worrying.

Figure 1: Smoke coming through the "Sorrento" side openings

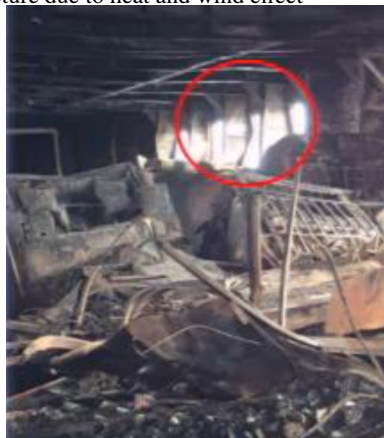
Figure 2: Evidence of major deformation of the "Norman Atlantic" starboard structure due to heat and wind effect

In a recent presentation<sup>18</sup> at the annual conference of *Interferry Association*, the Marine Research Division Chief of DIGIFEMA<sup>19</sup>, Fabio Croccolo, aimed that the spread of fire in the case of the "Norman Atlantic" was mainly due to the existence of large openings located on the sides of the ship, in the semi-opened decks, as well as the aft opening of the number 4 deck which allowed the step of strong wind gusts in the interior of the deck, stimulating the fire (the prevailing wind reached 43 knots).

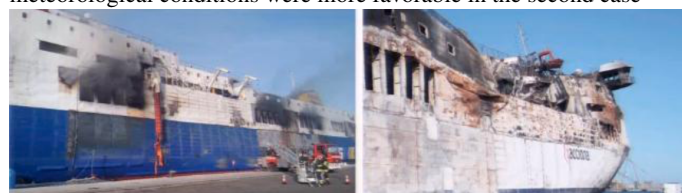
Therefore, in the case of the "Sorrento", the open design of several decks could have acted like a chimney and have accelerated the spread of fire.

Figure 3: Fire results in the case of "Norman Atlantic" (left) and "Sorrento" (right), where it can be seen that the second suffered far more damage, even though the fire started on the same deck (No. 4) and the meteorological conditions were more favorable in the second case

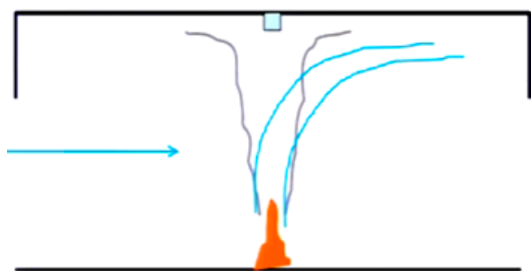
the same did not allow the shooting of many smoke detectors placed in the ceiling of the affected vehicle decks, because the smoke "plume" did not reach them because the wind effect in the hold.

In the case of the *"Sorrento"*, the affected decks were protected by smoke detectors, which as it has been discussed in advance could not be activated by enough anticipation, because the smoke "plumes" did not reach them because the prevailing relative wind in the open cargo spaces. That is to say, if the above mentioned system was covering the RO-RO "semi-opened" deck, as is required by regulations in force, the airflow through it could mean that the established darkening limits were not reached, with briefness, so that the smoke detectors did not enter into action.

Figure 4: Smoke "plume" movement due to transverse wind in a "semi-opened" deck

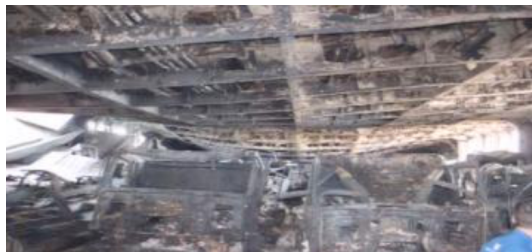
Figure 5: Current status of one of the affected decks of the "Sorrento"

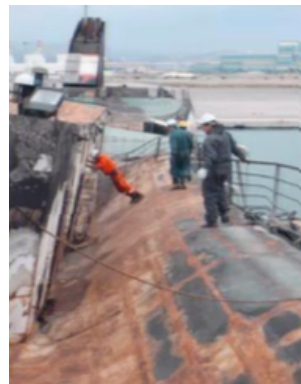
It can be assumed that in that particular zone, located immediately to the aft-port side structure of the bridge, due to

Figure 6: Current status of one of the "Sorrento" upper decks

the state of collapse that the building material presents there would be substances or flammable materials which contributed to magnify the effect of fire because the final results were more destructive than in the "*Norman Atlantic*" case. In the presentation of the DIGIFEMA chief at the 40th annual Interferry conference<sup>35</sup>, was also highlighted the problems that presented the "*Norman Atlantic*" VDR<sup>36</sup> (black box) to obtain the stored data. It was found that the computer was not sufficiently protected to withstand the suffered high temperatures, in fact only have been recovered the audio recordings, but the hard drive data could not be collected to date<sup>37</sup>. In the case of the "*Sorrento*" has not transcended the status of the VDR, but in view of the above mentioned will have to be the worst, given the state of the upper deck, where generally this equipment is located, presented an aspect more distressing than in the first case.

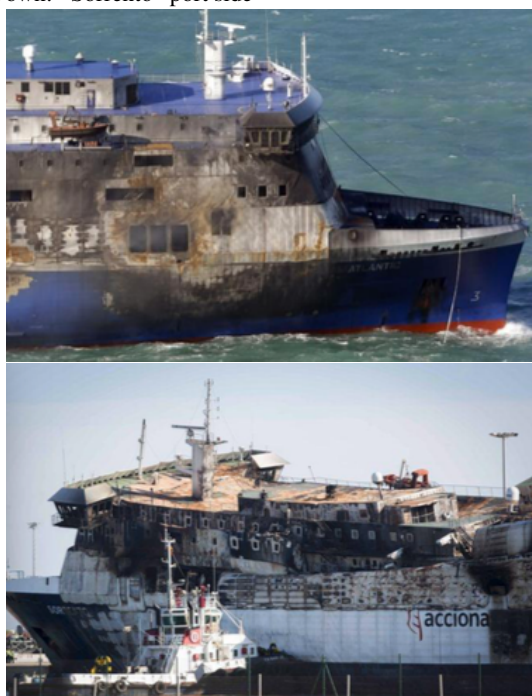
Which remained inoperative due to the heat and flames that came through the side openings, close to the starboard lifeboat deck, burned them (starboard MES<sup>34</sup>, liferafts and lifeboats could not be used).

Figure 7: Most affected sides by fire. Up: "Norman Atlantic" starboard side. Down: "Sorrento" port side
