Maintenance and Repair of Appendices Afloat on Ships Fast Ferries

ABSTRACT

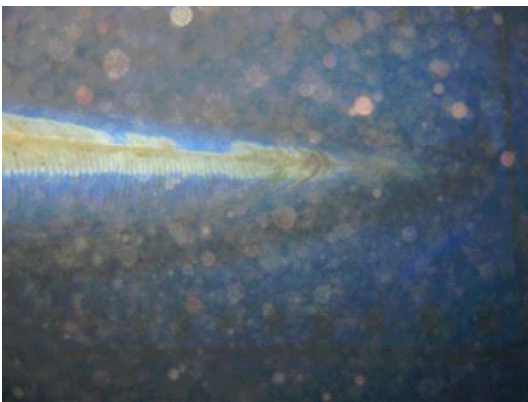
Figure 7: Paint loss on roll-fin stabilizer.

In the inspection of the Roll-Fin on the model vessel, two circumstances are observed: the first one, due to friction there is a loss of paint, an incidence due to the water during navigation (Fig. 7).

Looking carefully at the first verified circumstance in which the stabilizer blade damage was observed (Fig. 7), it is dismantled and transported to the surface by means of balloons, then hoisting it with a crane, which then is transported to the corresponding workshop to make the necessary repairs.

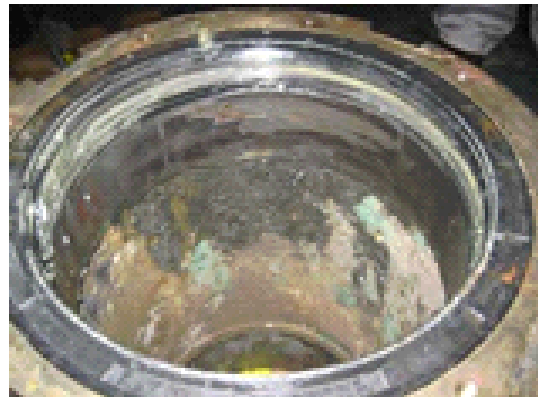
Figure 9: A break in the seals.

At first it is thought that the loss of water must come from a break in the seals, these can be changed without dismantling the yoke that supports the hydraulics. In the following picture you can see that the seals are broken even though the grease has done good lubrication.

When the seal is changed the loss of water starts again, this means that it is possible that the gap between the bearings and the shaft is too large. Before changing the housing is decided, with the supporting bearings afloat.

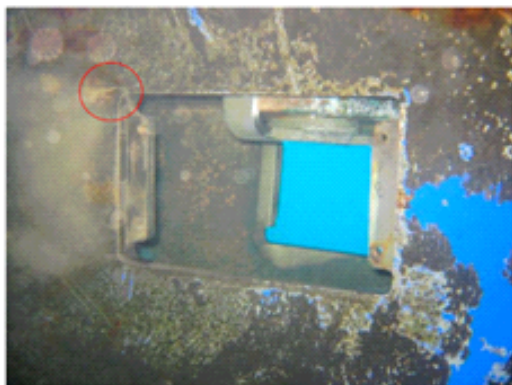
Figure 15: A crack in the hanging rudder.

A fault occurs on one of the hanging rudders due to breaks, with cracks in the covering where the rudder arm is held, as well as on the double hull fastening of the rudder.

Damage can occur during maneuvers, when the vessel is needed to go in the reverse direction, the flow of water is contrary to the design of the hanging rudders, producing enormous cavitations and vibrations. If we consider that many of these ships carry out an average of 8 to 10 maneuvers per day in which the maneuver lasts in the region of 5 to 10 minutes each, and in which the ship goes backwards for half that time. By extrapolation, we can say that this maneuver occurs 40 minutes per day, which is then 20 hours per month.

In the following picture you can see marked with a red circle, the crack produced in the observation window of the rudder.

The hanging rudder is dismantled by two divers on the outside and three operators on the inside, with a crane and balloons to hold the rudder in the sea and then the subsequent hoisting by means of the crane, which will be then carried by means of a transport vehicle to the corresponding workshop where the repair welding of the housing cover of the rudder's arm is undertaken. The painting is also done with.

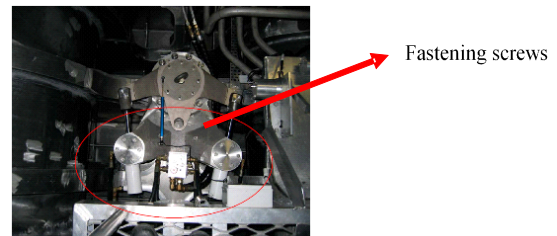
Figure 16: The Rudder's hydraulic drive system.

The rudder is only attached to the hydraulic drive system by the screws marked in Fig. 16, whereby the cylinders transmit the torque directly to the aforementioned screws.

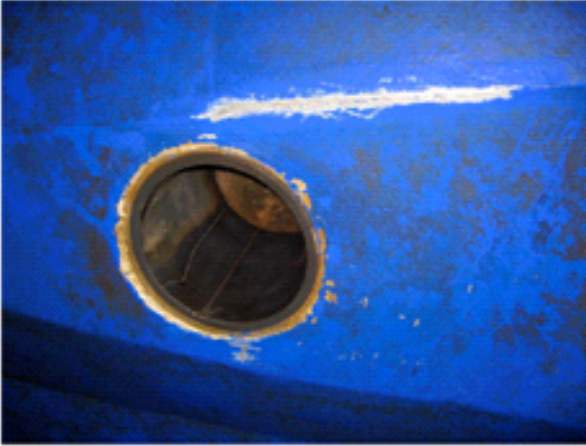
Figure 18: A crack in the hull.

Parallel to the whole situation, the repair of the crack produced in the rudder housing in the central hull of the vessel is carried out.

In order to repair the buried crack, the auxiliary vessel, described in section 2.1 of this article, is used, so that once it has coupled to the central hull, it is possible for work to be made on the crack.
