Squat and Bank effect as a consequence of unintentional grounding of vessels: Study of cases

J.A. González-Almeida^{1,*}, J. M. Chillón García², M. C. Adrián de Ganzo¹, F. Padrón³, A.U. Gómez-Correa³

Squat effect, Bank effect, Unintentional grounding.

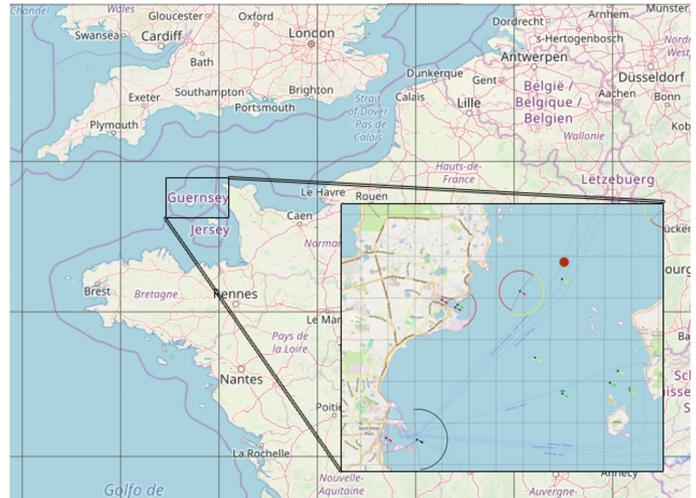
Figure 7: Commodore Clipper accident location.

At 1515 on 14th July 2014 the passenger ferry Commodore Clipper, grounded while approaching its destination at St. Peter's Port in Guernsey, where it hit bottom on a rock. After the grounding the ferry was able to continue sailing to its port of destination. Subsequently, once in port and after a visual underwater inspection, it was found that the hull had been significantly damaged with breaches and waterways.

All appeared normal after that, so much so that once in port, and once unloaded, they began to load again to leave again, while routine (pre-programmed) underwater visual inspection work was carried out, where it was found that considerable damage had been sustained to the hull as a result of the grounding, with several spaces in the double hull being found full of water due to the breaches that were found.

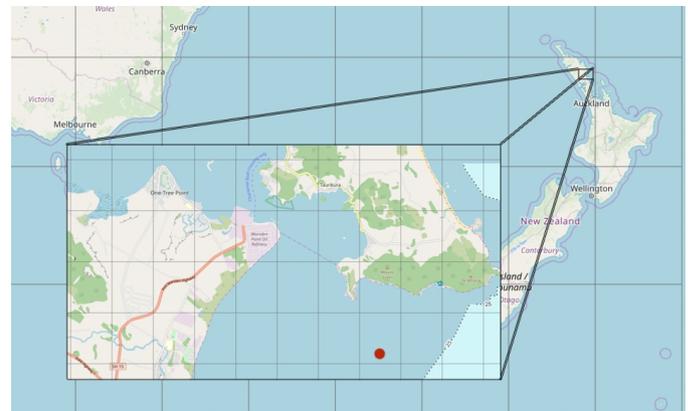
Figure 10: Capella Voyager accident location.

In total the ship hit bottom twice in her movement, but was able to continue sailing until berthing, during which time it was observed that the bow peak was damaged and water was entering. The ship was moored at her berth at 2036 hours.

- In the proximity of where the Capella Voyager beached, a difference in channel depth was found in just 2 cables from 18.5m to 14.6m, which is considered to be a significant variation affecting the squat effect differently than if it were over a constant bottom.

- The Pilot's calculation of UKC was to add 10% to the draft. He did not include in his calculations either the squat effect or the effect of the sea.
- With the UKC noted on the pilot card of 2.1m the investigator considered the grounding to be almost inevitable with the sea conditions combined with the squat effect that was generated.

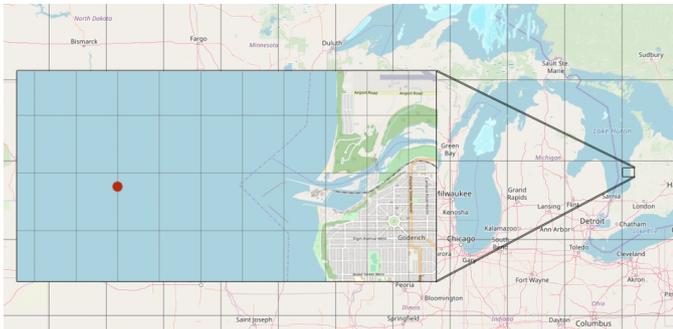
Figure 12: Canadian Transfer accident location.

As the ship gained speed, the Second Officer, who was the officer on watch for navigation, arrived on the bridge, and received the Captain's orders for navigation and calculations to arrive at the agreed ETA. This exchange was carried out by the two of them on the bridge's quarterdeck, at the back of the bridge, while they took a quick look at the ECPINS to check that everything was OK. The vessel at the time was sailing 1.6 cables north of the port departure track at a speed of 11.4 knots when a loud booming sound was heard. According to the crew it sounded as if an anchor had been let go in to give anchorage, so they even went to check that both anchors were stowed in place, which they found they had hit bottom.

Because of the damage caused to the hull of the vessel, a heel of 6 to 8 degrees to portside was generated and the incumbent Captain, after taking command, took the decision to anchor.

- The routine speed used to leave Goderich Harbour is 6-7 kts, which, had this been the case that day on the Canadian Transfer, would have caused a squat of 0.29 to 0.39m,

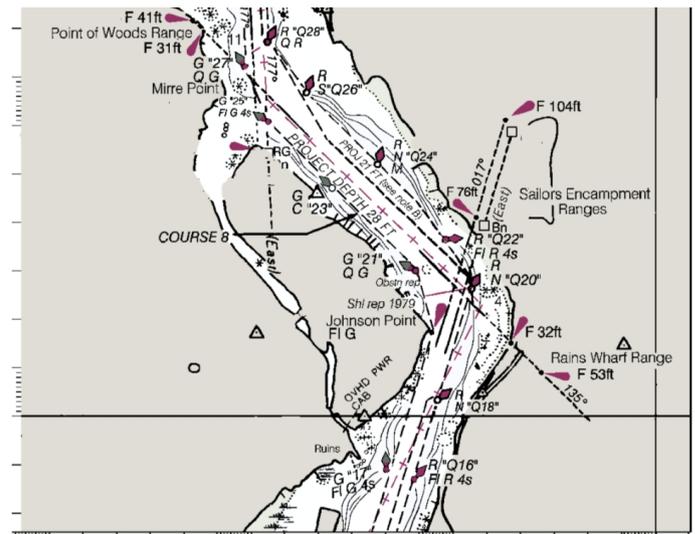
Figure 19: Johnson Point where the Algontario beached.

The Algontario was approaching from the left hand side of the sidelights and the skipper moderated the engine to obtain a speed of 7.1 kts off buoy Q18 (see Figure 19). At 0439 when about 60 m from Johnson Point through Br and already more than half a length past that point, the Captain ordered all Br to make the turn around the bend and increased the engine to 6 points to gain rudder steerability.

The grounding occurred on the starboard side up to the stern, several ballast tanks were damaged and the ship heeled over and rested on the edge of the fairway.

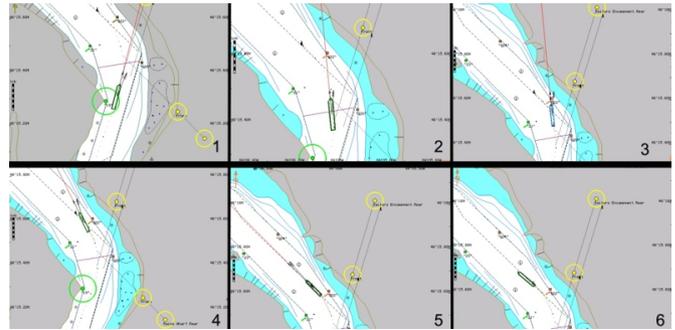
Figure 20: Evolution sequence of the Algotario at Johnson Point.

The bend was a left turn of about 63° change of course and as the rudder came all the way to portside, the ship began to fall back to the same side. The Master and the officer on the bridge followed the evolution of the ship's fall and noticed that

3. The action of the 2 kts of current against, influenced portside’s tack, pushing the bow against the intended direction of the ship’s turn.

To rescue the ship from the grounding, a plan to lighten the ship’s fuel had to be carried out, as well as to release all the ballast from the undamaged tanks, and it was refloated at 1830 hours on 7th april.

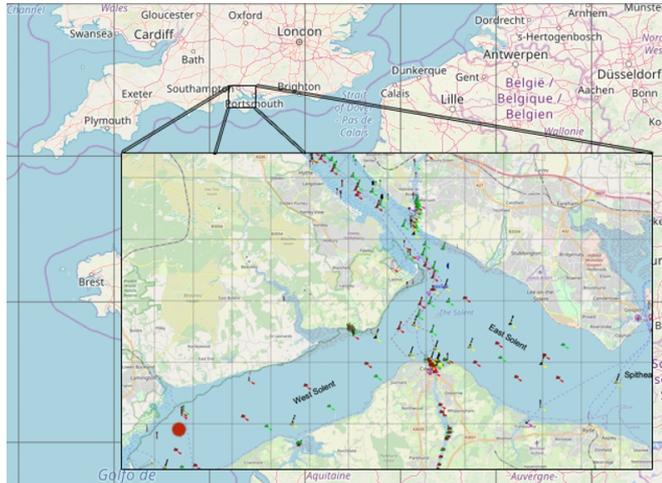
Figure 22: Attilio Ievoli accident location.

At 1805 the Attilio Ievoli was clear of the grounding and after underwater inspection was found to have no major damage. Subsequently, the investigations revealed that (Marine Accident Investigation Branch, 2005):

- From 1600 to 1642 various calls were made on the ship’s mobile phone from the bridge. During the grounding, a call from the Master was in progress.
- According to the data recorded on the VDR it was found that from 1614 to 1624 the course set on the autopilot was 249° when the planned course was 246°, so the ship was gradually drifting away from the plotted course.
- At 1924 there began to be a slow drop from course 249° to 240°, but as noted on the rudder log, the rudder was attempting to regain course by setting rudder 10° to Er, from which it is inferred at that time the ship was experiencing suction on her stern from the navigable limit of the channel, causing the bow to drop to Br and the autopilot was attempting to correct by setting rudder to starboardside.

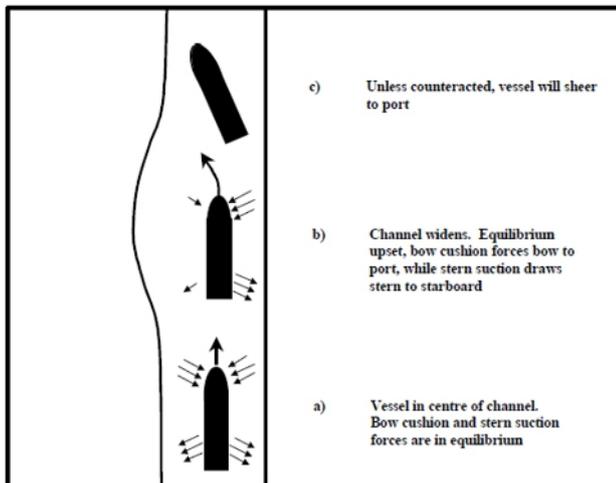
Figure 23: Schematic diagram of the effects of the canal on the Kakariki.

The investigation found that the cause of the sudden yaw was due to a combination of the following:

- As the ship was approaching the starboard bank the Pilot (who was on training) suggested putting the rudder to portside to return to the centre of the channel just as the helmsman was at starboard rudder to counteract the bank effect of the starboard bank.
- Just at that moment the boat was moving from a narrower part of the channel to a more open part of the channel to portside, causing the NSL to be on the port side of the boat.
- Just such a change coincided with a moderation in the engine which led to less effective rudder.
- The boat was also experiencing squat at the bow causing the turning point of the boat to move to the bow of the boat, resulting in oversteer.
- The team on the bridge did not notice the yaw until it occurred and reacted with some delay.

No accident occurred in this case, but it is noteworthy because of the circumstances surrounding the event, so much so that an investigation was initiated which in this case recommended a new dredging of the channel to reduce the blockage factor that used to occur and the continuous interactions that were generated in the transit of the channel by different ships.
