Identification the Cause of Decreased Main Air Compressor Performance in Relation to the Duration of Air Bottle Filling at MT. Giat Armada 01

Main Air Compressor, Spring Delivery Valve, L.P Delivery Valve, H.P Delivery Valve.

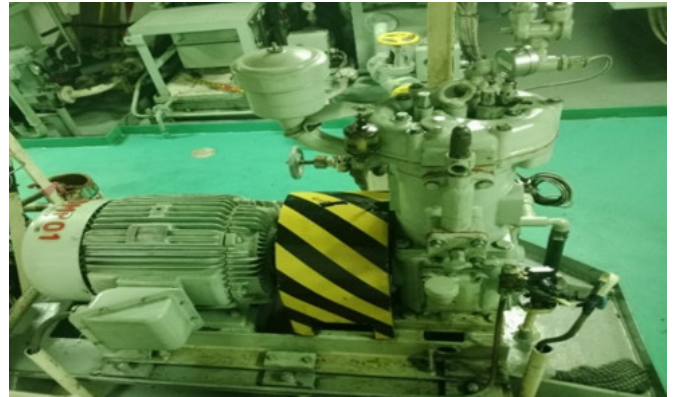
Figure 2: Main Air Compressor 01.

MAC no. 01 which decreased by looking at the pressure gauge on the low pressure delivery valve which decreased from ± 0.5 bar to ± 0.2 bar in actual MAC No. 01. To identify the cause and repairs require time while the ship must remain operational, the chief engineer ordered Machinist III to start MAC No.02 while still monitoring and checking MAC No. 02 while underway so that the ship can remain operational.

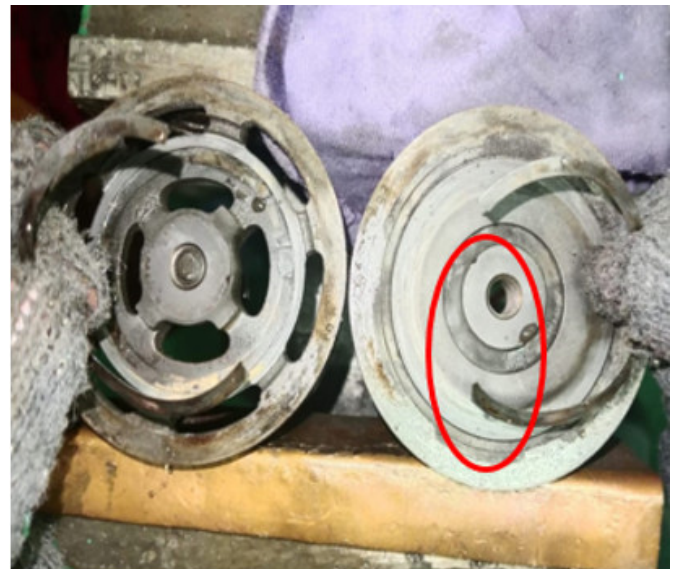
Figure 4: Spring delivery valve.

From Figure 4, it can be seen that the spring delivery valve low pressure is broken. Spring valves made from materials that cannot withstand repeated workloads or certain environmental conditions can experience material fatigue and ultimately break. Excessive heat can also cause the spring valve to break if particles of dirt, dust or metal debris enter the valve. in the

compressor it can increase the workload on the valve spring to a greater extent which can result in the valve spring breaking or material that is too stiff or inelastic can become susceptible to fracture due to repeated workloads. And also spring valves that are old or have been used for a long period of time can experience wear or structural damage that causes them to break. In the instruction manual book the spring delivery valve low pressure is replaced after 1500 hours of work/operation.

Based on the description of the causes that have been explained, the effort that can be made to overcome the broken spring valve delivery low pressure is to replace the low pressure delivery valve spring. After making the change, observe the main air compressor when it is turned on and make sure the pressure on the pressure gauge is in accordance with the instruction manual book. So that this incident does not happen again in the future, it is necessary to replace the spring valve delivery low pressure when its service life approaches 1500 working hours, so that the low pressure valve can work optimally.
