Shoreline Detection using Image Processing for Coast of Pangandaran

O. Pattipawaej^{1,2,*}

The aim of this study is to investigate the shoreline changes at the coast of Pangandaran, Indonesia, which is a popular destination either for domestic or international tourists. The shoreline at the coast of Pangandaran is obtained by using satellite imagery from Google Earth Pro for 10 years. The shoreline change rate is estimated using a simple statistical method. The rate is used to predict the shoreline change using arithmetic sequence. The forecast of Pangandaran's shoreline changes in the year 2030 are the largest abrasion of 3.2 m and the largest sedimentation of 0.7m. Efforts to prevent changes in Pangandaran's coastline is planting soft and/or hard structures. Further research requires analysis of coastal protective structures such as mangrove and/or breakwaters.

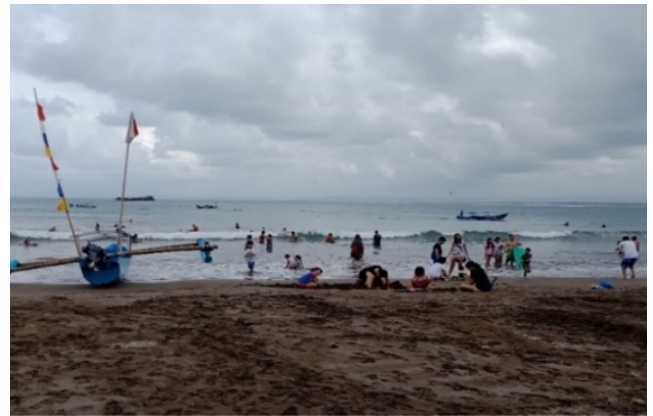
Figure 2: Condition of the Pangandaran West Coast at Coordinates $07^{\circ} 41' 52,64''$ S; $108^{\circ} 39' 09,20''$ E.

The first stage was carried out field observations on Pangandaran coastal area. The thing to do is to inspect the location, observe the coastal area, such as: abrasion, land use around the coastal Pangandaran, and community activities around Pangandaran coastal area. The condition of Pangandaran coastal can be seen in Figure 2 to Figure 4.

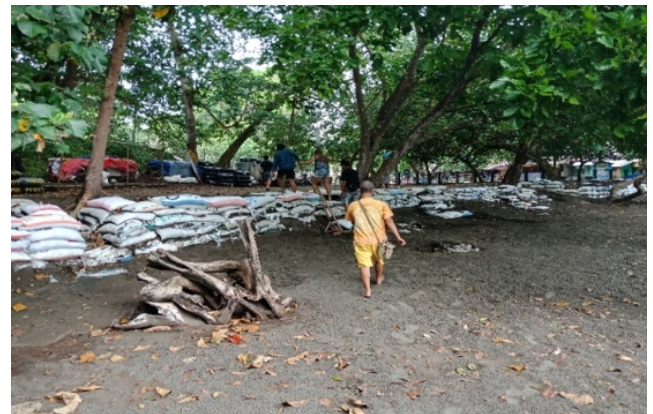
Figure 3: Coastal Condition of Batu Hiu coastal in Pangandaran at Coordinates $07^{\circ} 41' 33,72''$ S; $108^{\circ} 32' 18,76''$ E.

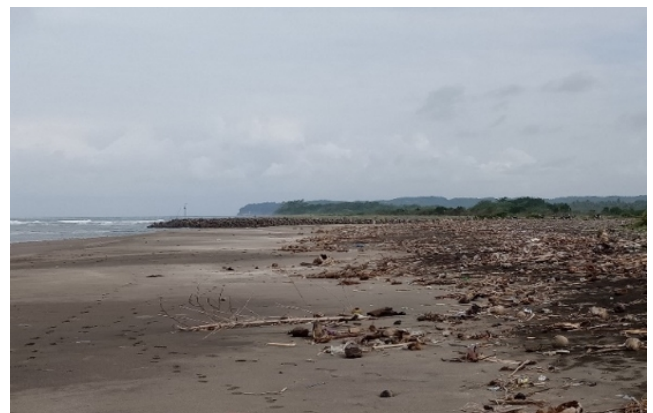
Figure 4: Condition of the Batu Hiu coastal area in Pangandaran at Coordinates $07^{\circ} 42' 09,71''$ LS; $108^{\circ} 30' 41,52''$ BT.

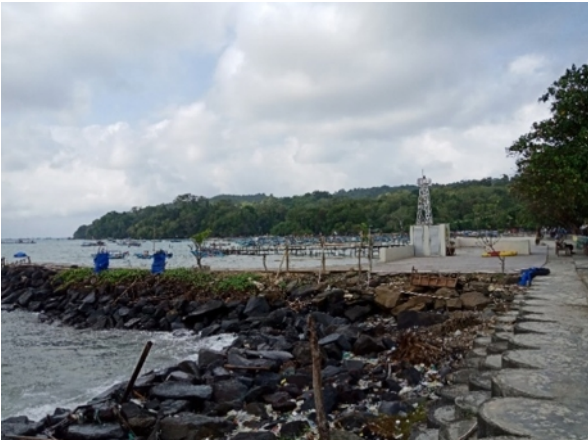
Figure 5: Condition of Breakwater in East Coast Pangandaran at Coordinates 07° 41' 55,62" S; 108° 39' 33,20" E.

The condition of breakwater at Pangandaran Beach can be seen in Figure 5 to Figure 7.

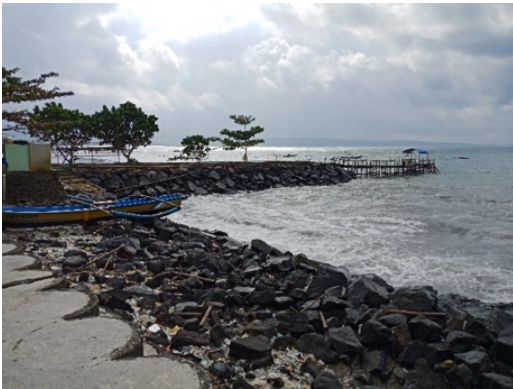
Figure 6: Condition of Breakwater in the East Coast Pangandaran at Coordinates 07° 41' 54,69" S; 108° 39' 33,54" E.

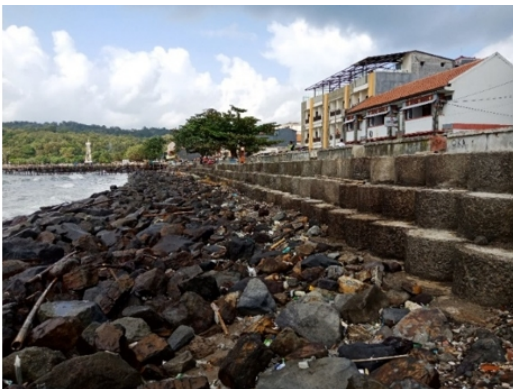
Figure 7: Conditions of Breakwater in the East Coast Pangandaran at Coordinates 07° 41' 55,93" S; 108° 39' 33,23" E.

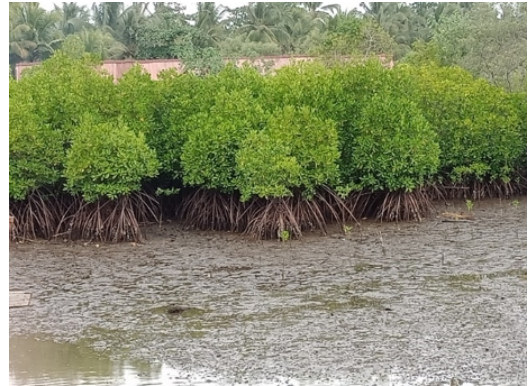
Figure 8: Plant Condition Part 1 on the Batu Hiu at Coordinates 07° 41' 33,72" S; 108° 32' 18,76" E.

Planting plants around Pangandaran coastal area which is used as a barrier to erosion and/or sedimentation can be seen in Figure 8 to Figure 9.

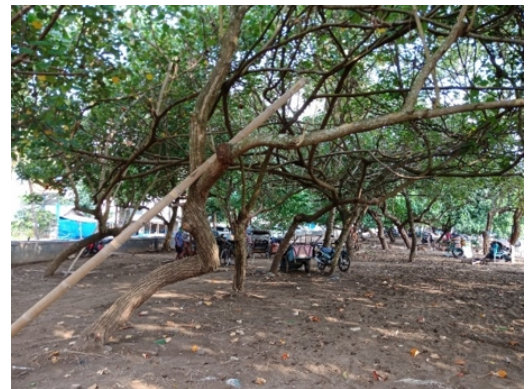
Figure 9: Condition of Plants Section 2 on the West Coast of Pangandaran at Coordinates 07° 42' 03,47" S; 108° 39' 23,20" E.
