## COMBUSTION PROCESS IMPROVEMENT IN A MARINE DIESEL ENGINE

### ABSTRACT

**Keywords:** marine engines, internal combustion engines, diesel engines, combustion, environmental impact.

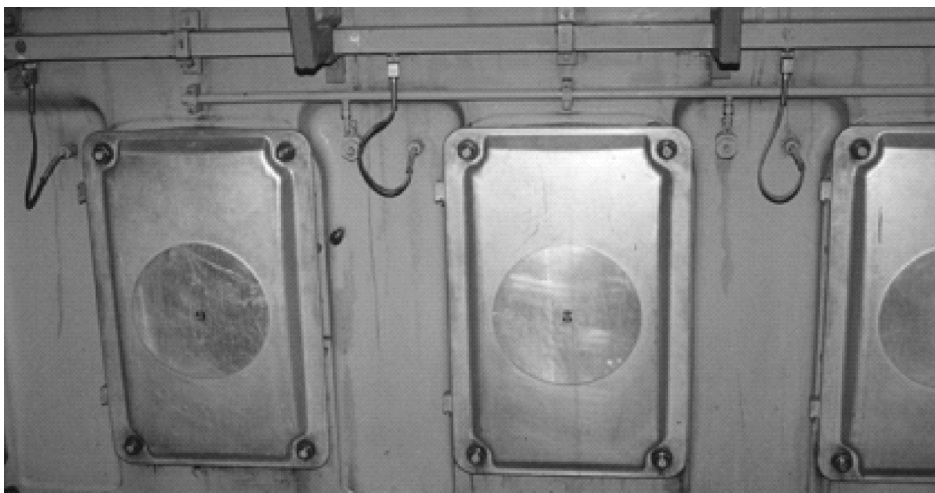
Figure 4: Permanent wiring for main bearing temperature monitoring

The temperature of every main bearing was obtained using the engine monitoring system, fitted for such purpose with permanent temperature sensors and electrical wiring [*Figure 4*].
