Maritime accidents in passenger ships and derivative liability: Costa Concordia and Sewol

J.A. González-Almeida^{1,2}, F. Padrón^{1,3}

cruise, passenger, safety, Costa Concordia, Sewol.

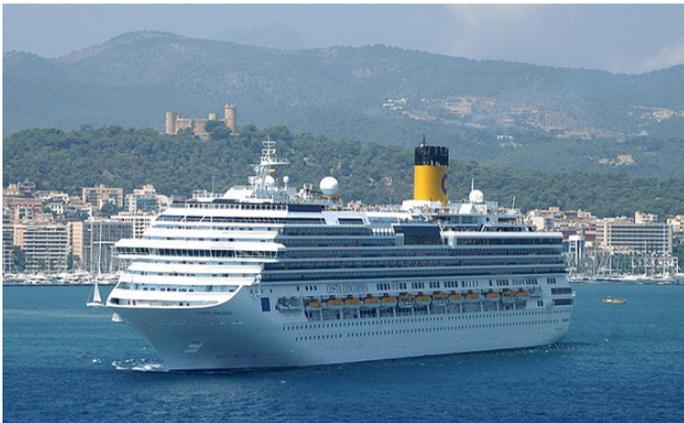
Figure 1: Costa Concordia Cruise.

The Costa Concordia, built in 2004 by Fincantieri in Sestri Ponente, Genoa, Italy, was one of the most luxurious ships of the Costa Cruises shipping company.

by Captain Francesco Schettino. The ship came too close to the coast, and the contact with the rocks at the bottom led to the creation of a waterway of about 70 meters along the hull, which in a short time caused the ship to list to its side starboard, which led it to be heavily heeled, with the serious consequences of 32 dead, and 4197 evacuated.

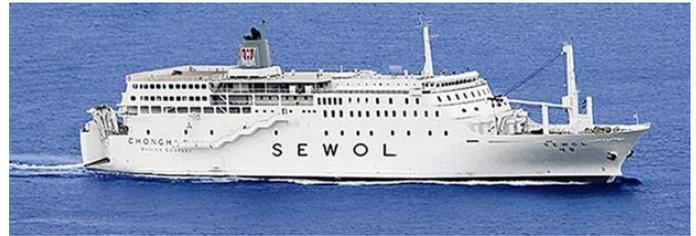
Figure 6: Ferry MV Sewol.

The Sewol, a passenger Ro-Ro ferry, was delayed leaving Incheon Port for Jeju Island on April 15, 2014. The ship issued a distress signal at 9:00 local time the following day, when he was near the Jindo islands, in the Maenggol channel, 3 hours from his destination. During the passage through this channel, the ship made a sudden change of direction. At that moment, the passengers heard a strong blow (possible collision or shift of cargo) and saw the ship begin a fast list towards the port side. The passengers, mostly high school students, did not move from their places, at all times obeying the orders they had been given from the public address system. When they wanted to escape it was too late since the water was entering and the list was so large that it was impossible to leave the ship. The Sewol would end up sinking with hundreds of people trapped inside (just over 300 dead), leaving the bow bulb out of the water and the stern sunk 30 meters deep (Suh & Kim, 2017).

- Date: April 16, 2014
- Hour: 9:00 (Local time)
- Cause: Sharp 15° turn that caused the ship to heel and be unable to regain stability due to overload and structural changes that had altered its center of gravity.
- Place: Maenggol Canal, near the Jindo islands.
- Coordinates: 34° 13' 55" N, 125° 57' 00" E
- Last stop: Incheon.
- Arrival port: Jeju City.
- Passengers: 443.
- Crew: 33.
- Casualties: 299 (on-board, 2 rescue divers and 5 emergency workers)
- Survivors: 172.
