## Investigation of High Exhaust-Gas Temperature in Cylinder No. 2 of the Main Engine on KM. Rucitra VII

This research was conducted on KM. Dharma Rucitra VII, owned by PT. Dharma Lautan Utama. The ship is a RoRo-Passenger type with a Surabaya-L.Bajo-Maumere, NTT route.

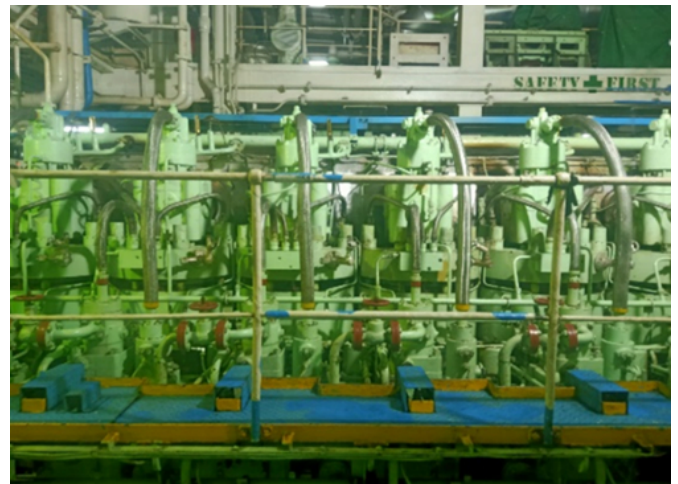
Figure 2: Main Engine.

According to Pertamina (2022) Diesel engines use a two-step principle in the combustion process. Compressed air enters through the blower side of the turbocharger into the combustion chamber, pushing the piston upward. As the piston slowly moves upward, the air is compressed, causing the combustion chamber to heat up. Fuel is then injected, triggering an explosion in the combustion chamber that pushes the piston downward. The injector component plays an essential role in the combustion process.

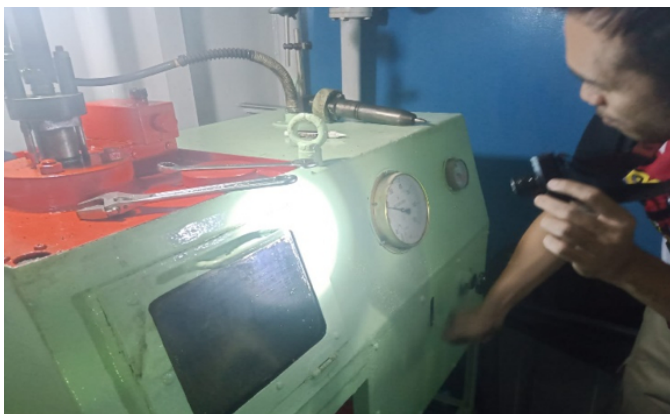
Figure 3: Injector Pressure Test.

Checking the injector fogging pressure using the injector fogging pressure test tool when the ship is alongside at the port of Maumere, NTT.

The decreased performance of the injector is caused by the condition of the tip of the injector nozzle dripping, resulting in

incomplete combustion with a waste of fuel that produces black smoke coming out of the ship's chimney.

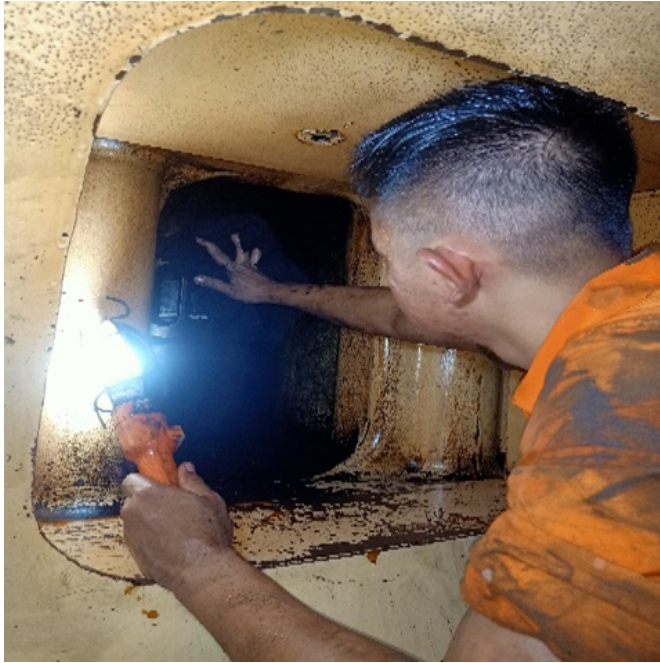
Figure 5: Cleaning the scavenging air chamber of cylinder no.2 on main engine.

When the researcher and driver inspected the scavenging air chamber, they found that the rinse air in the scavenging cylinder no. 2 was dirty. The dirt came from the accumulation of cleaning residue in the rinse air chamber. Dirty scavenging air chamber ducts can cause less clean air flushing so that it can reduce the amount of fresh air entering cylinder no.2 of the main engine. As a result, the exhaust gas is not entirely wasted, so that combustion in the next cycle is not optimal and can increase exhaust gas temperatures.

Cleaning the scavenging air chamber on cylinder no. 2 of the main engine can lower the exhaust gas temperature of cylin-

der no. 2 of the main engine, and the clean air flow helps maintain a stable temperature in the cylinder.

Clean the scavenging air chamber of cylinder no.2 on main engine can prevent the accumulation of air rinse residue, thereby facilitating air flow and improving engine performance. Cleaning the rinse air duct.
