Maintenance and Repair of Appendices Afloat on Ships Fast Ferries

ABSTRACT

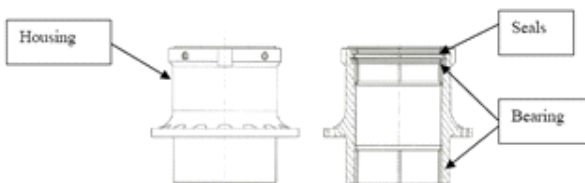
Figure 8: Bearing housing with seals.

The second circumstance is that there is a loss of water through the seals, despite checking that the grease is used correctly.

At first it is thought that the loss of water must come from a break in the seals, these can be changed without dismantling the yoke that supports the hydraulics. In the following picture you can see that the seals are broken even though the grease has done good lubrication.

These facts imply the dismantling of the bearings mounted

All the parts are disassembled and all the elements are cleaned and the housing is replaced with the new bearings.

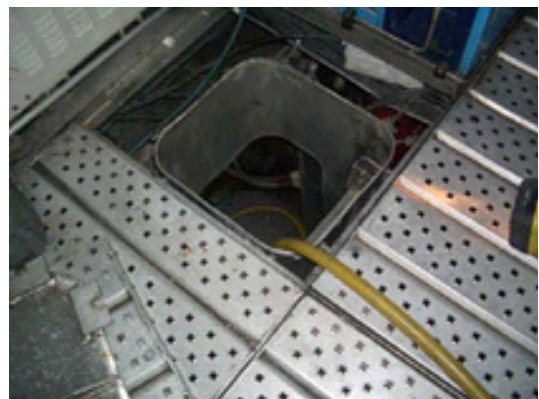
Figure 10: Roll-fin cofferdam.

The roll-fin has a completely sealed space in such a way that it allows a total water tightness of the area.

As soon as the dismantling begins, two divers on the outside work to place two sectors between the hull and the axis of the roll-end, to make it watertight and that water getting in is at a minimal, or that it is to say, to be taken care of by the bilge pump system. Divers need to be immersed inside the vessel in the confined space, so it has to be well cleaned because when it is flooded and the diver enters, there can be no oil residue as

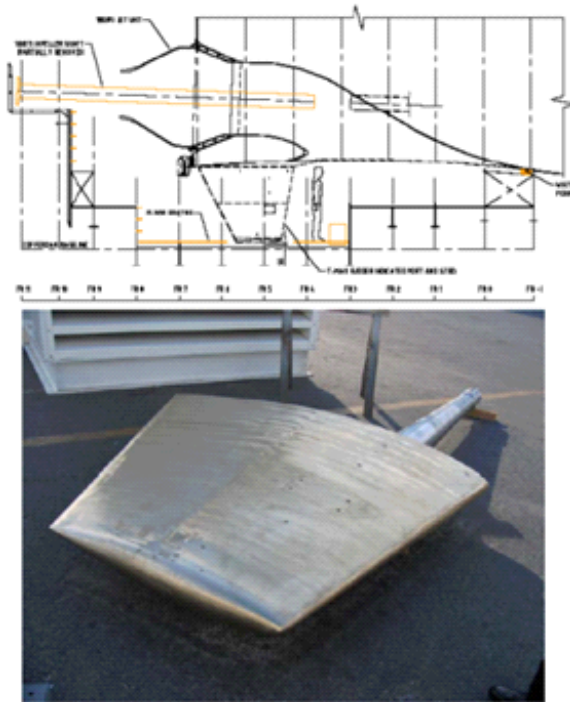
Figure 14: The hanging rudder of the trimaran.

A fault occurs on one of the hanging rudders due to breaks, with cracks in the covering where the rudder arm is held, as well as on the double hull fastening of the rudder.

Damage can occur during maneuvers, when the vessel is needed to go in the reverse direction, the flow of water is contrary to the design of the hanging rudders, producing enormous cavitations and vibrations. If we consider that many of these ships carry out an average of 8 to 10 maneuvers per day in which the maneuver lasts in the region of 5 to 10 minutes each, and in which the ship goes backwards for half that time. By extrapolation, we can say that this maneuver occurs 40 minutes per day, which is then 20 hours per month.

The hanging rudder is dismantled by two divers on the outside and three operators on the inside, with a crane and balloons to hold the rudder in the sea and then the subsequent hoisting by means of the crane, which will be then carried by means of a transport vehicle to the corresponding workshop where the repair welding of the housing cover of the rudder's arm is undertaken. The painting is also done with.
