Numerical failure Assessment of a Double-hull Tanker Ship colliding with a Container Ship

Ship Collision, Double-hull tanker ship, Structural failure, Non linear finite element method, Total absorbed energy, Bow penetration.

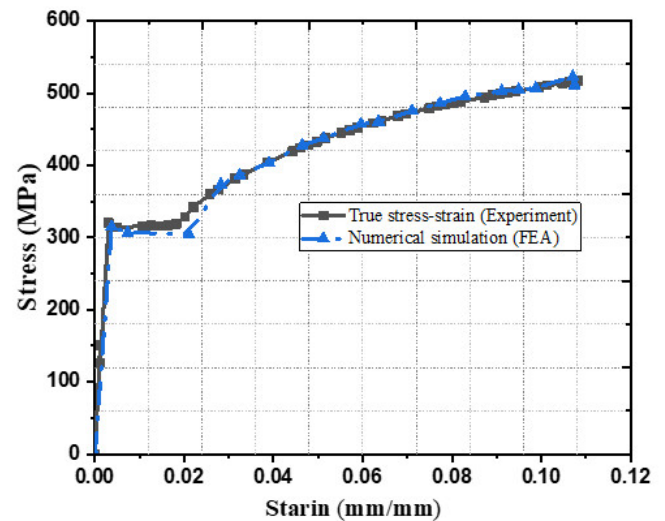
Figure 1: True Stress - Strain tensile curve for steel grade A36.

Material calibration based on the engineering tensile test is important to enhance the numerical results and to obtain a reliable finite element model (MacLean, 2012). In addition, stress triaxiality is highly recommended (Ganjani and Homayounfar, 2021; Sajid and Kiran, 2018). Fig. 1. shows a comparison between the numerical tensile model and true stress-strain experiment. It can be observed that the two curves almost coincide, and good results are achieved. However, a slight difference was observed in the plateau region. The plastic strain is given as follows:

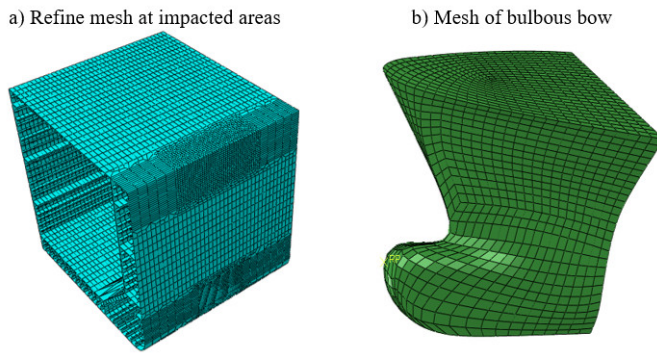
Figure 4: Mesh density and finite element type of ship-ship collision.

It should be noted that structural failure mainly occurs in the impacted area of the struck ship. Therefore, the accuracy of the simulation results was strongly linked to the appropriate boundary conditions and refined elements in the impacted area. Further, an appropriate mesh refinement should be used to capture all structural deformations resulting from the collision. (Liu et al., 2018) . Fig.4.a shows the mesh refinement at contact area of the outer shell side. A quadrilateral shell element (S4R element) is used in this simulation (Obisesan, 2017) . To better visualize the effect of the impact on the ship's hull, we released the degrees of freedom that corresponding to the impact direction. The impacted region subjected to fixed boundary conditions in the longitudinal ends.

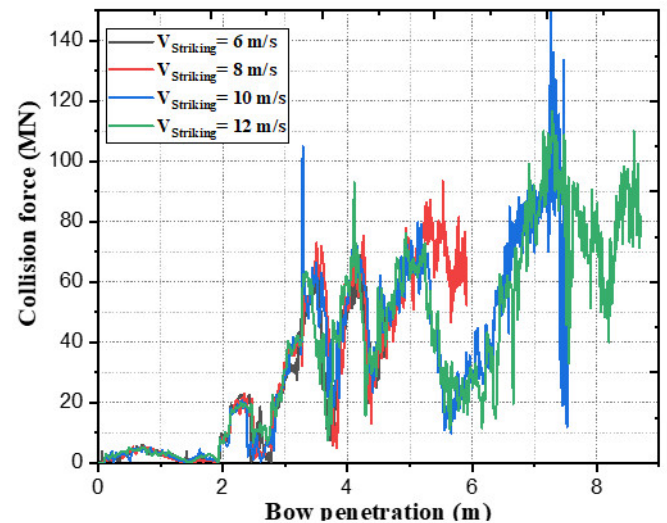
Figure 7: Collision forces versus bow penetration at different ship velocities.

Fig. 7 shows the collision force history as a function of bow penetration during the collision process for different velocities. All curves follow a non-linear relationship, indicating a complex interaction between the impacted area and the rigid bow. Peaks and fluctuations were recorded in the range of 0.0 to 1.2s.

Each of these peak values denotes the critical point at which the bow penetrates structural parts. Two maximal peaks were observed. the first one is related to the fracture of the outer hull side and the second is accompanied by the fracture of the inner hull side. A strong decrease in the impact force was noted due to the total fracture of the impacted region. It is shown also a progressive penetration of the bow into the hull side of the ship, where the displacement increased steadily. This increase in displacement directly correlates with the collision force applied to the struck ship. The deepest penetration was observed at a velocity of 12 m/s. The maximum displacements reached by the velocities (6, 8 m/s, 10 m/s, and 12 mm/s) were (4.59m, 5.89m, 7.39 m, and 8.59 m) respectively. Fig. 8. illustrates the absorbed energy in terms of displacement. The total absorbed

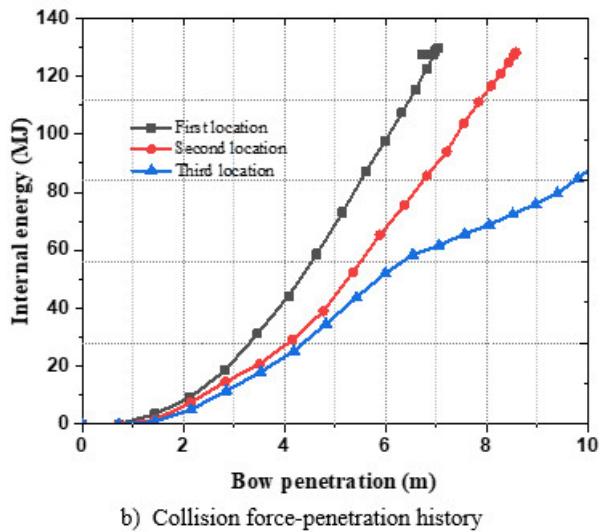
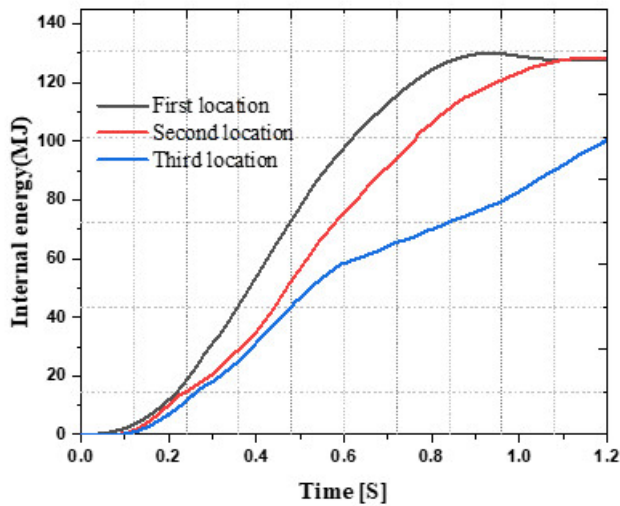
Figure 10: Comparison of collision force data for the proposed locations.

Fig. 10. shows a comparison between the proposed impacted regions regarding collision force versus time (Fig. 10.a), and displacement (Fig. 10.b). The deepest bow penetration was obtained at the third impact location. However, It was relatively small at the first impact location because of the strength capacity along the vertical direction of the side hull structure. It should be mentioned that the structural integrity at the first location has a superior resistance compared to the other collision impact locations. additionally, higher absorbed energy is attributed to the first location, whereas less energy is absorbed simultaneously for the second and third locations. The energy absorption capacity depends on the structural elements of the hull.

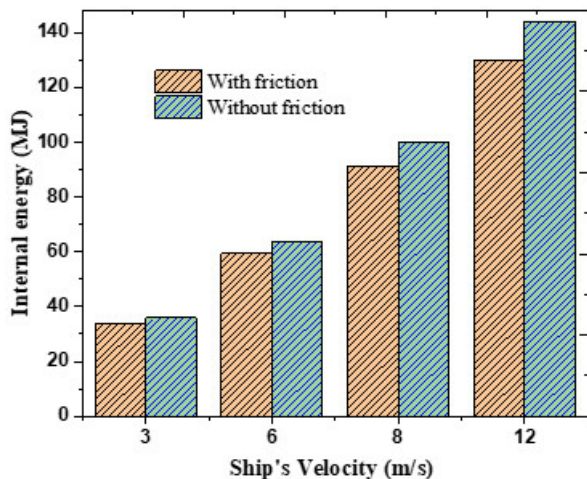
Figure 11: Contribution of friction coefficient on the absorbed internal energy for different ship's velocities.

Friction coefficient values (0.1, 0.23, 0.3, and 0.4) were chosen according to the literature, in order to evaluate its effect on the dissipation of energy during the collision simulation. Fig. 11. shows the influence of the friction coefficient on the total absorbed energy for different ship velocities. Compared to

the case without friction, it is clear that the friction coefficient contributes to the total energy. Furthermore, this contribution has a significant effect when the ship's velocity increased. Fig. 12 shows that the effect of friction becomes more pronounced when bow penetration increases. However, for a small penetration (from 0 m to 3.5 m), this effect was almost negligible. With a higher friction coefficient, there was more resistance, leading to a slightly higher force at the moment of impact. The obtained results indicated that the effect of the friction coefficient is not significant compared to other collision parameters. This finding is confirmed (Wiśniewski and Kołakowski, 2003; Zhang et al., 2019)

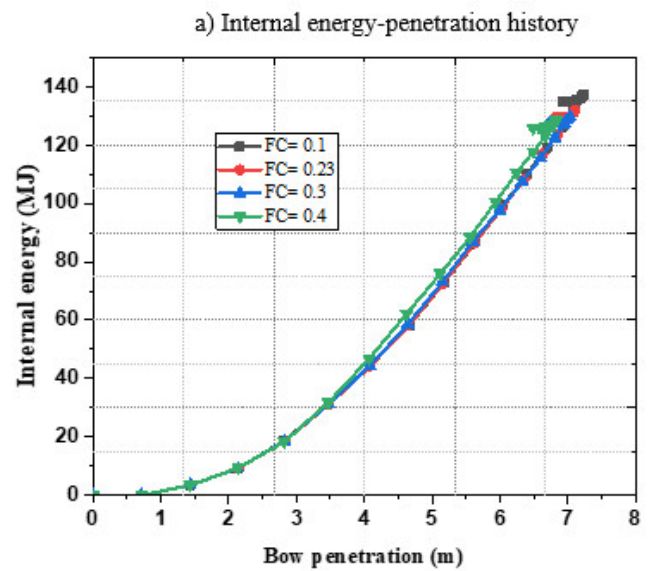
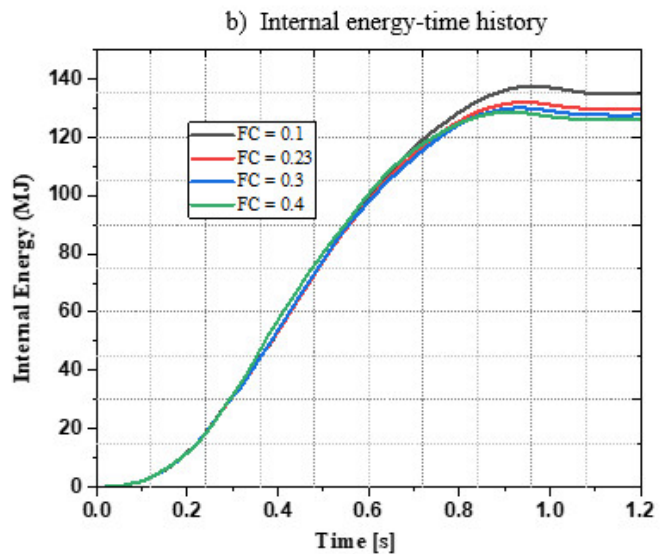
Figure 12: Absorbed energy during a collision event for different friction coefficients.

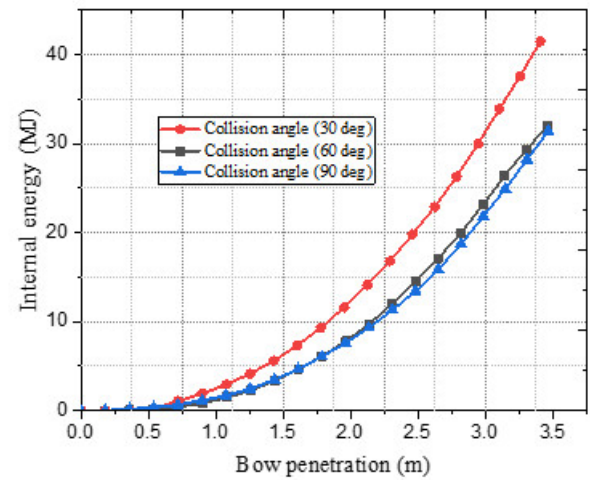
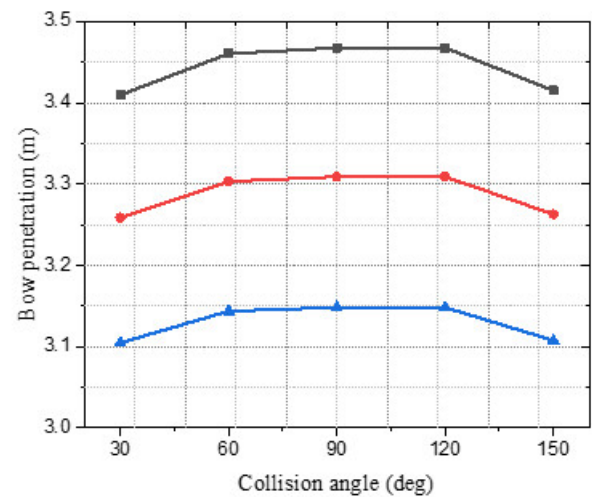
Figure 14: Effect of collision angle on the structural response of the impacted ship .

b) Bow Penetration versus collision angle

This section investigates the effect of collision angle on the structural response of a double-hull ship. Several angles were considered, varying from 30 to 150 degrees. Fig. 13 shows a cut-view of the structural damage during a ship collision at various angles. From Fig. 14, it is evident that the right angle (90 degrees) has a significant effect compared to other angles. Higher absorbed energy is attributed to the 30-degree angle. It is concluded that the angle at which the impact occurs affects the distribution of forces and energy transfer between the ships, influencing the penetration depth and the location of damage along the hulls.
