## Analysis of the main causes of Spanish fishing vessels sinking

Fishing Vessel, Stability, Safety

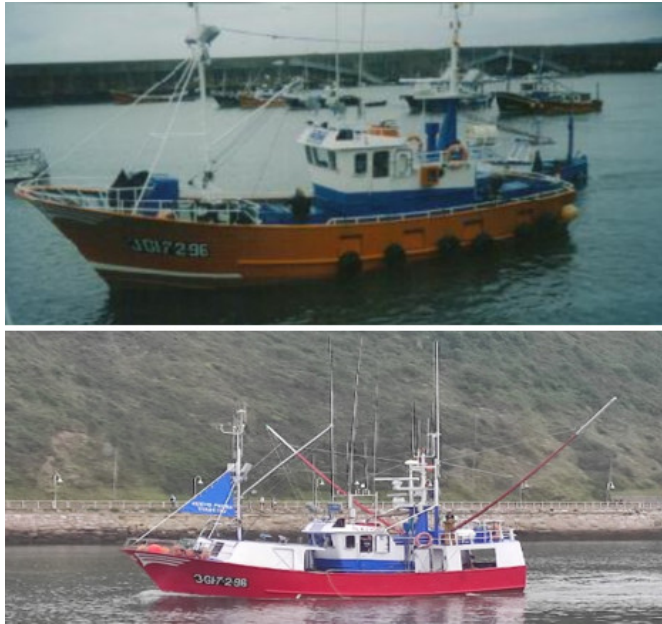
Figure 2: Constructive evolution of fishing vessels, the “Nuevo Padre” boat, an artisanal fishing boat of 16,5 meters in total length dedicated to bottom longline fishing.

The construction of modern fishing vessels is influenced by European policies that impose restrictions on the usable spaces below the last continuous deck, known as their net tonnage [21]. However, these regulations permit the installation of enclosed high spaces to enhance onboard conditions for fishermen during their work. For example, Figure 2 provides a visual demonstration of these high spaces installed on the last continuous deck of the ships.

Moreover, the installation of these enclosed high spaces disrupts the natural drainage mechanisms traditionally present in vessels. This can lead to water accumulation in the fishing hold, exacerbating stability issues and increasing vulnerability to water ingress incidents. An example of such vulnerability is observed in the case of “O Terror Dos Mares” (2019).
