A Review of the MS Berge Istra Accident

ABSTRACT

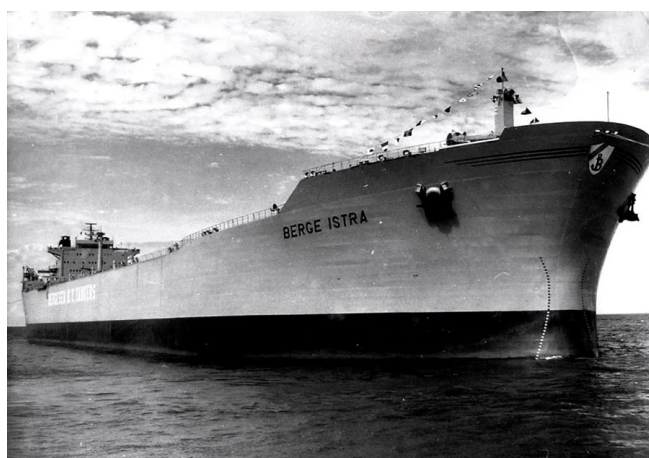
Figure 1: Photo taken in Vitória, Brazil in 1974, one year before the accident.

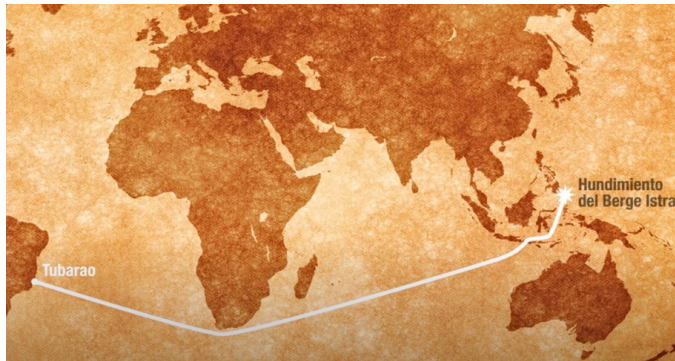
Figure 2: Voyage of the MS Berge Istra up to the moment of the accident.

On December 30, 1975, during one of its regular voyages, the MS Berge Istra disappeared in the Pacific Ocean near the island of Mindanao in the Philippines. The last communication with the ship was recorded in the early hours of the morning, and following that, no further information was available regarding its location. The official declaration of the ship's disappearance was made a week later, on January 7, 1976, and despite extensive search efforts, no wreckage was found. This event generated significant concern not only within the maritime community but also among the general public, resulting in widespread media coverage [4].
